GUIDELINES FOR ROOFING

Town of Riverhead Landmarks Preservation Commission

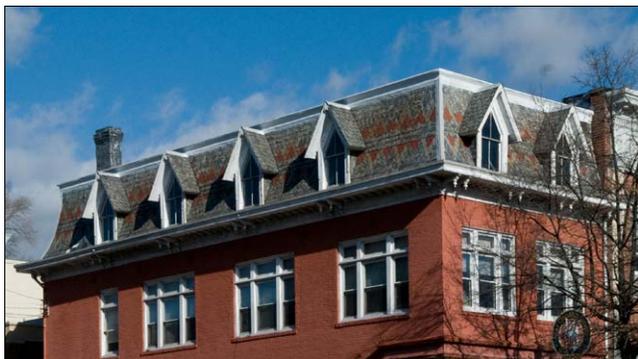
This represents one of the few commercial buildings on Main Street with a highly decorative roof treatment. This Mansard roof is covered with three colors of fish scale slate installed in a decorative pattern and trimmed along its edges with painted metal flashing. A series of steeply pitched gable roof dormers with projecting eaves provide additional habitable space at the upper level. Also note the projecting roof cornice with the paired decorative brackets, typical of the Victorian period.

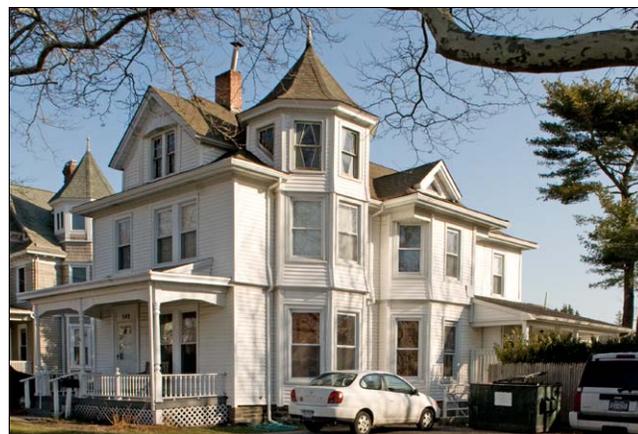
Residential buildings, particularly those from the Victorian period, tend to have very complex roof forms that can include intersecting gables, dormers and towers.

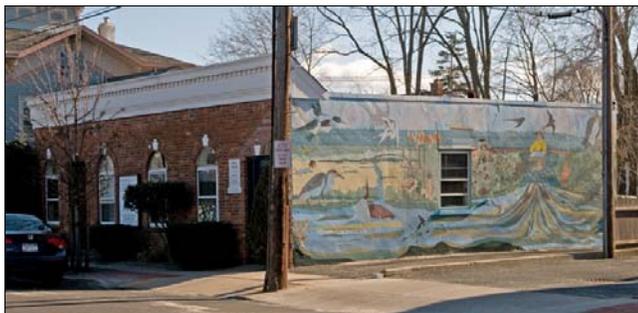
This commercial building has a decorative cornice at the front elevation, but a lower flat roof is evident at the side elevation.

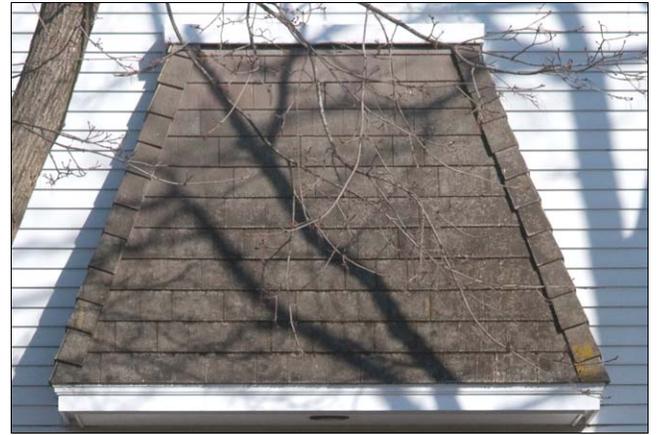
Wood shingles are not as common as they were historically in Riverhead.

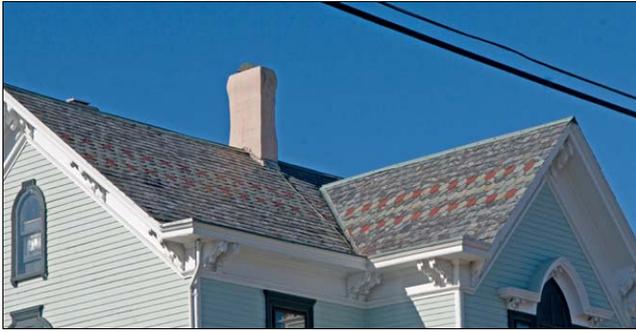
This Victorian slate roof has multiple colors and patterns.

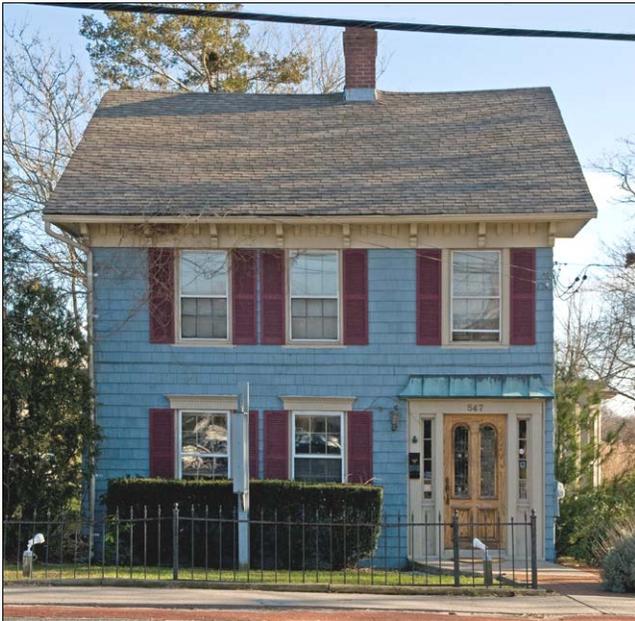
The asphalt shingle roof simulates the appearance of wood shingles. Also note the standing seam copper hood above the entrance door.

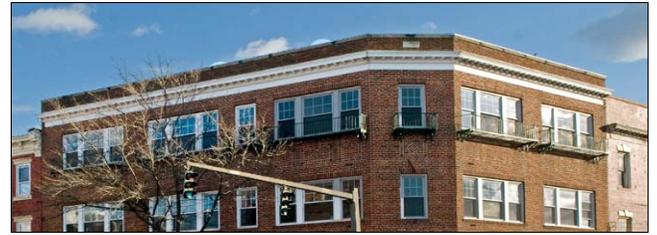
Most Main Street commercial buildings along have flat roofs.

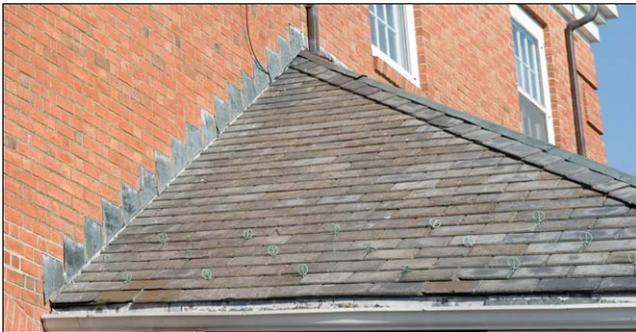
Stepped copper flashing is visible where the slate porch roof intersects the brick wall.

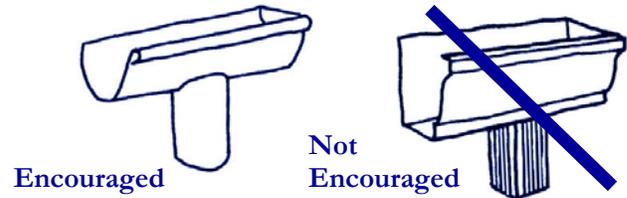
Half-round gutters with round or rectangular downspouts are preferred to decorative gutters with corrugated downspouts.

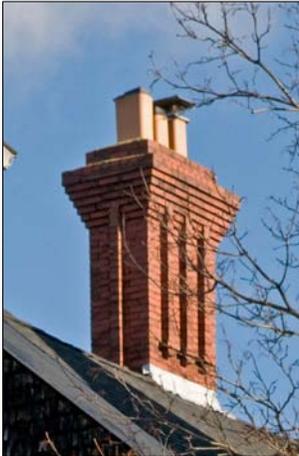
Victorian era chimneys tend to include more decorative detailing such as the articulation of the verticality in the “piers” and the corbelling at the top. This example also includes terra cotta chimney pots. Also note the metal flashing at the base of the chimney, at location that is highly susceptible to moisture infiltration.

Chimneys were typically designed to complement the style of a building and period of construction. In Riverhead, many are constructed of brick more rarely stone, some of which have been covered with stucco. Most styles of building, including Colonial Revival and Classical Revival buildings, tend towards square or rectangular chimney shafts, sometimes with molded caps. Victorian period chimneys can include decorative detailing including corbelling, varied patterns, undulating and molded surfaces and decorative terra-cotta chimney pots.

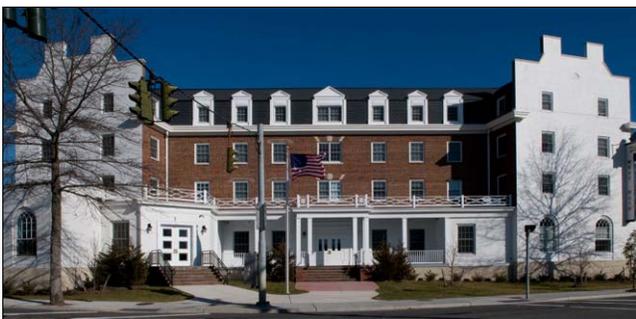
Dormers can provide additional habitable space, particularly at gambrel and mansard roofs.

Dormers, also known as dormer windows, protrude from the roof surface with a window at the downward slope, providing light and additional headroom under roof eaves. Dormers can have various roof shapes including gables, shed, hipped, eyebrow, segmented pediment and other shapes.

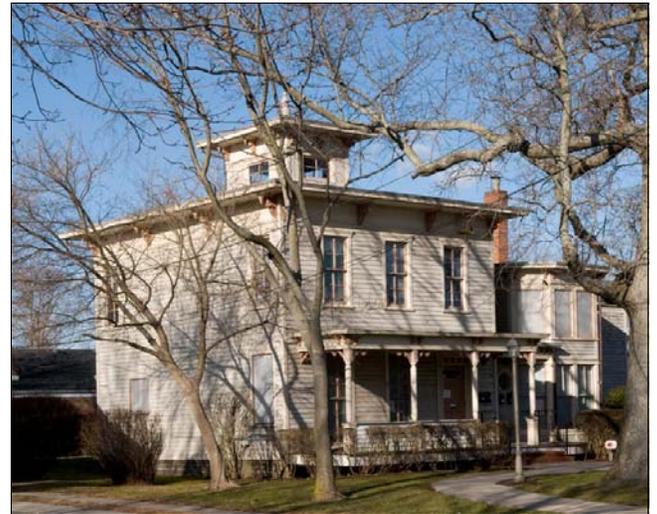
Historically in Riverhead, cupolas can be found at some high-style Italianate residences. Also note the projecting bracketed cornice and shallow pitch roof, typical of the Italianate style.

Cupolas, also known as monitors or belvederes, are structures that project up from the roof, used for ventilation with louvers, or as lookouts with windows. They are often found on agricultural outbuildings to provide ventilation for the animals housed below, but can also be found in urban areas as a decorative feature on important residential, institutional or civic buildings.

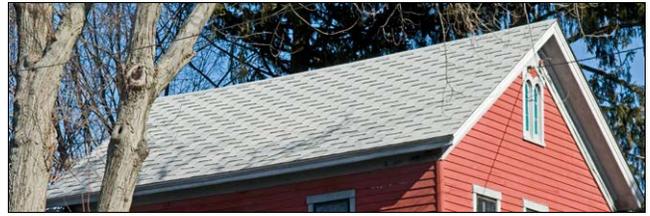
The shingles provide a unique pattern on the roof surface.
