AviationSafetyNetwork

Status: Final
Date: Saturday 15 August 1959
Time: 16:42

Type: [Boeing 707-123](#)
Operator: [American Airlines](#)
Registration: N7514A
C/n / msn: 17641/36
First flight: 1959-05-06 (3 months)
Total airframe hrs: 736
Engines: 4 [Pratt & Whitney JT3C-6](#)
Crew: Fatalities: 5 / Occupants: 5
Passengers: Fatalities: 0 / Occupants: 0
Total: Fatalities: 5 / Occupants: 5
Aircraft damage: Damaged beyond repair
Location: 5 km (3.1 mls) NE of Calverton-Peconic River Airport, NY (CTO) ([United States of America](#))
Phase: Approach (APR)
Nature: Training
Departure airport: [Calverton-Peconic River Airport, NY \(CTO\)](#), United States of America
Destination airport: [Calverton-Peconic River Airport, NY \(CTO\)](#), United States of America
Flightnumber: AA514

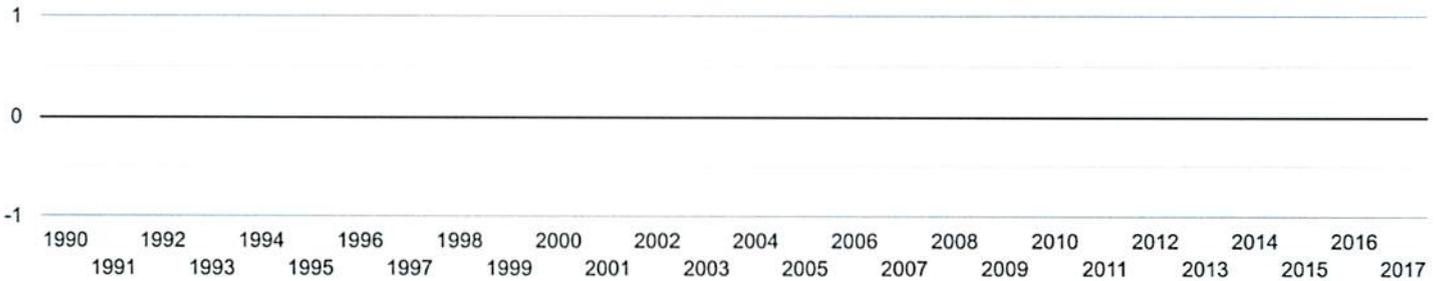
Calverton-Peconic River Airport, NY - Wildlife strike reports

number of birdstrikes and other wildlife strikes reported to the FAA through December 31, 2016 and important strikes through December 31, 2017
