GUIDELINES FOR EXTERIOR MAINTENANCE

Town of Riverhead Landmarks Preservation Commission

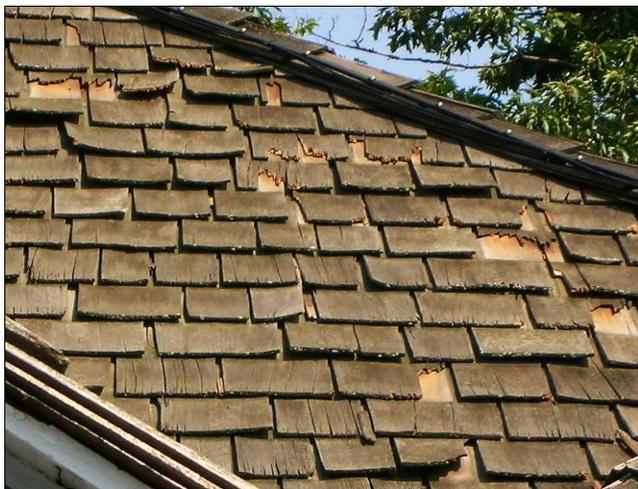
This wood shingle roof has reached the end of its useful life. The majority of shingles are cupped or split, exposing the underlying shingle surfaces. The prevalence of the problem will necessitate full roof replacement.

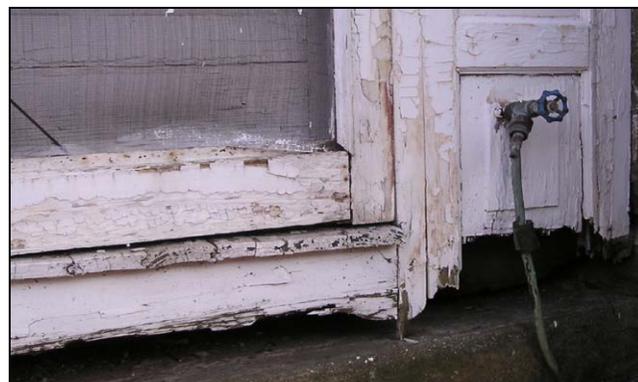
The wood base is in contact with the concrete foundation. Regular wood dampness can eventually lead to rot and deterioration, necessitating future replacement.

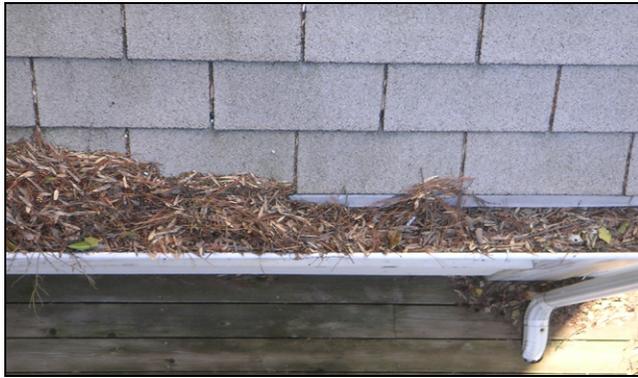
The regular cleaning of gutters and downspouts is one of the most effective preventive maintenance tasks. Clean gutters and downspouts provide a means for moisture that accumulates on the roof to be directed away from the building without causing damage. This gutter is filled with leaves, twigs and debris preventing clear drainage and allowing water to overflow the gutter and damage exterior wall surfaces. Gutters and downspouts should be cleaned at least twice each year to minimize potential problems.

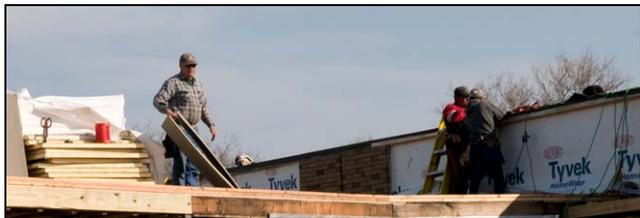
Regular review of roofing can alert property owners to when replacement is needed.

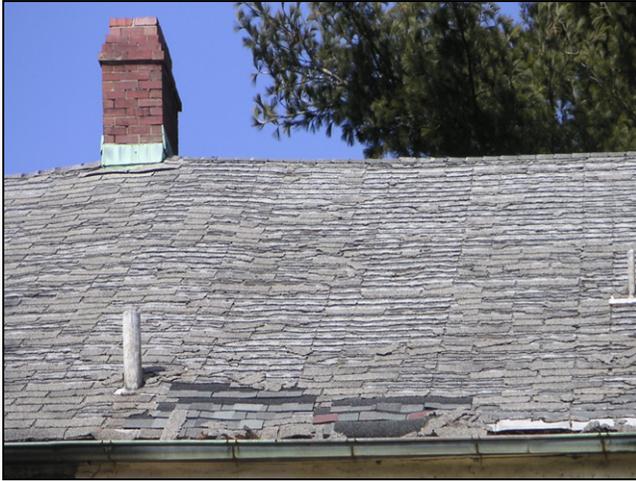
The mineral granules on the asphalt shingles have almost completely worn away. Portions of shingles have broken off and can be found in the gutters and on the ground. Prior patching is evident at the edge of the roof. The top of the roof curves down from the chimney, a possible indication of a structural problem.

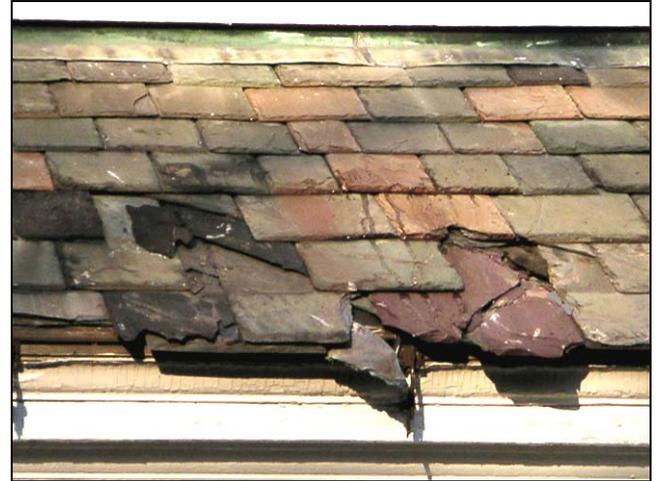
Slates are cracked, dislodged and missing. Some of the surfaces are delaminating. Approximately 25 to 30 percent of the slates on this roof are either missing or damaged. Given the pervasiveness of the problems, considering roof replacement would be appropriate.

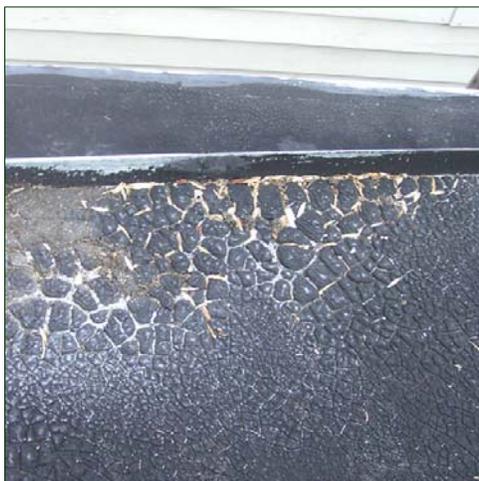
The alligatored roof surface indicates roof deterioration and possible need for replacement.

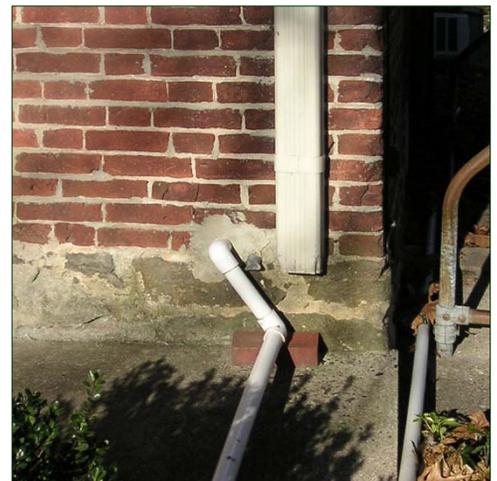
The downspout is discharging immediately adjacent to the building onto a concrete surface. The storm water splashing onto the concrete surface can saturate the masonry wall.

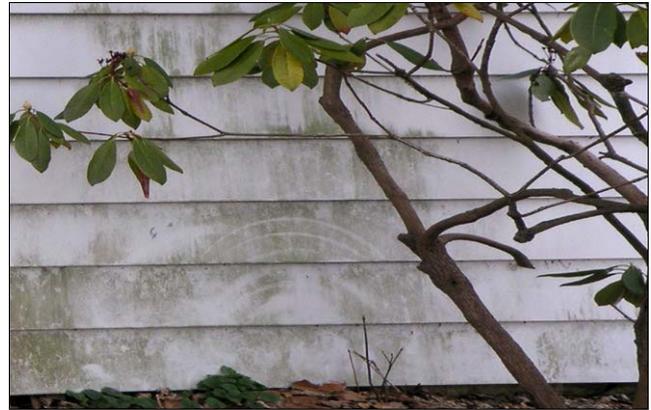
The siding staining is an indication of mold or algae growth. The shrubs should be removed or thinned to increase ventilation and allow sunlight to strike the wall. The siding is located only 2 to 3 inches above grade making it susceptible to water damage.

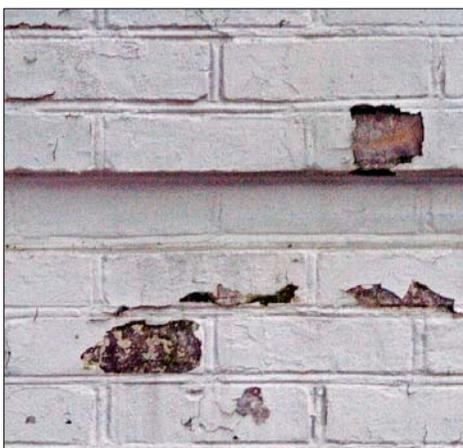
The loose, flaking paint should be removed and the cause for peeling determined. It is likely that the paint was not intended for masonry applications or the surface was not properly repaired and prepared prior to painting.

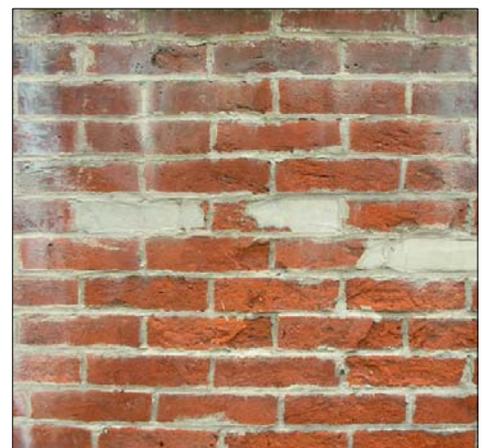
Inappropriate treatments can damage the surface of older and softer masonry. The rough texture and uneven surface in this example suggest an aggressive cleaning method was used. Also note the stucco patches and surface efflorescence.

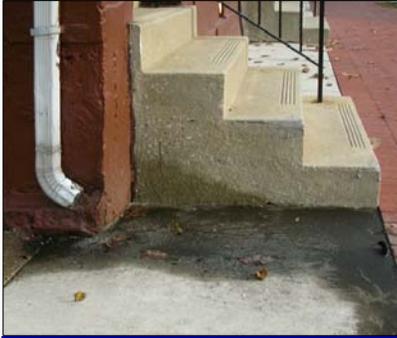
The water staining and sediment at the base of the downspout is an indication of water ponding. Installing a splash block or downspout extension would direct storm water away from the building.

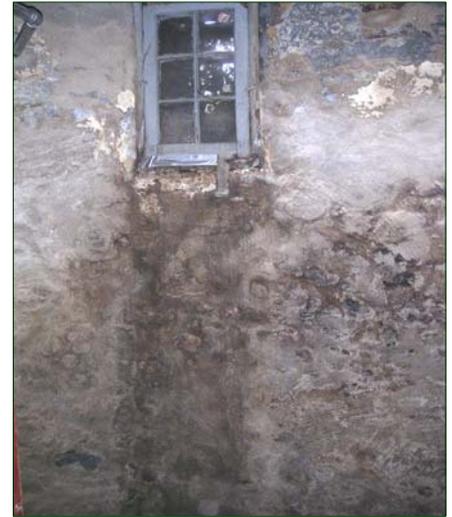
The darker area of the lower portion of the wall surface and area immediately below the window is an indication of dampness. Remedying the source of moisture infiltration and additional ventilation is recommended.

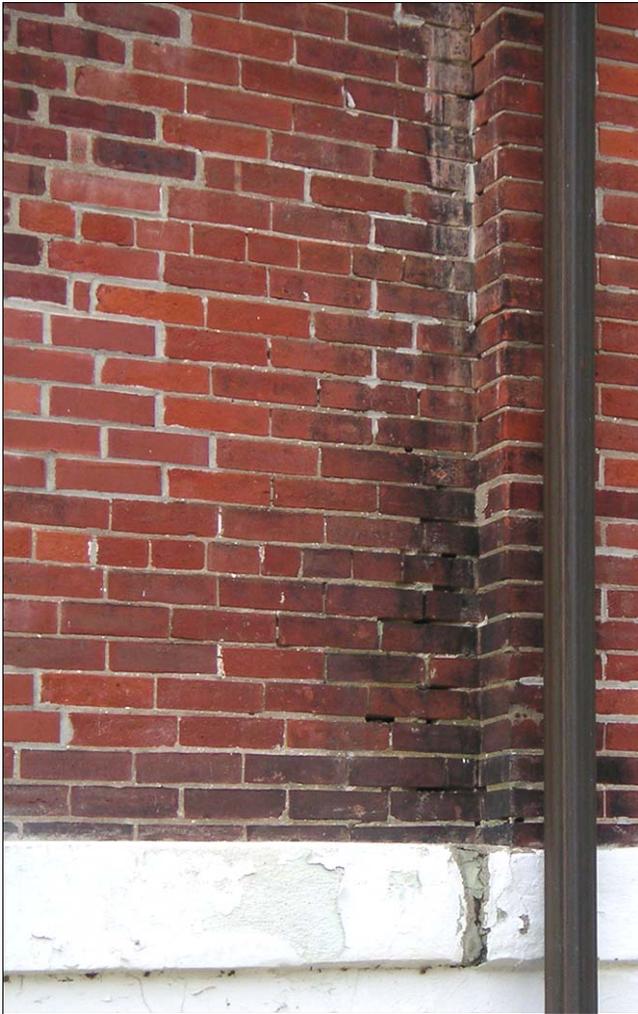
Problems with the downspout have resulted in deterioration of the mortar joints and efflorescence and staining of the brick surface. The projecting water table has been previously patched with stucco and the paint is peeling from both the water table and foundation below. There have been various repointing efforts of the brick as evidenced by the different mortar colors and joint styles.

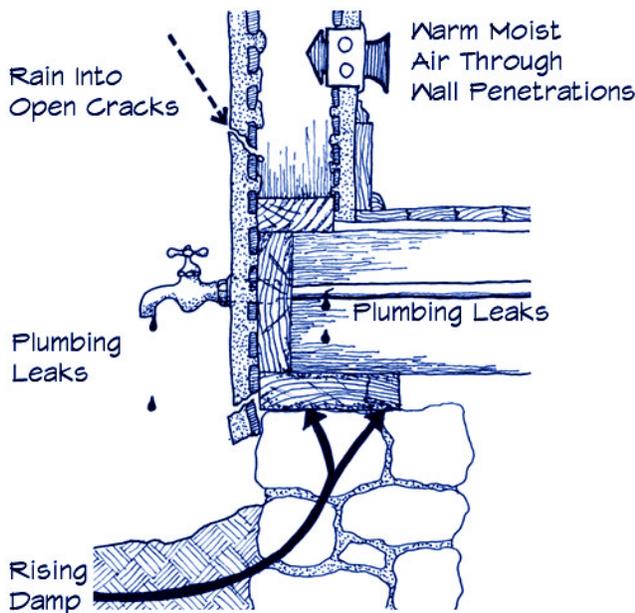
Rain and Precipitation can enter the exterior envelope through damaged or cracked surfaces and crevices with adjacent materials including window and door frames.

Rising Damp is the migration of moisture from the soil into the building structure through capillary action. The soil adjacent to the foundation can become saturated through improper drainage from gutters and downspouts and vegetation planted adjacent to the foundation.

Plumbing Leaks include piping as well as bathroom fixtures, kitchen and laundry appliances, and underground piping.

Condensation occurs when warm moist air from bathrooms, kitchens and laundry facilities comes in contact with cold surfaces and changes to water droplets.
